Tan yr Wyddfa Hut Sub-Committee & Hut Custodian 2008 to 2013 - Tony Howard

Dry Rot Treatment at South End of Building: October 2008 – April 2009

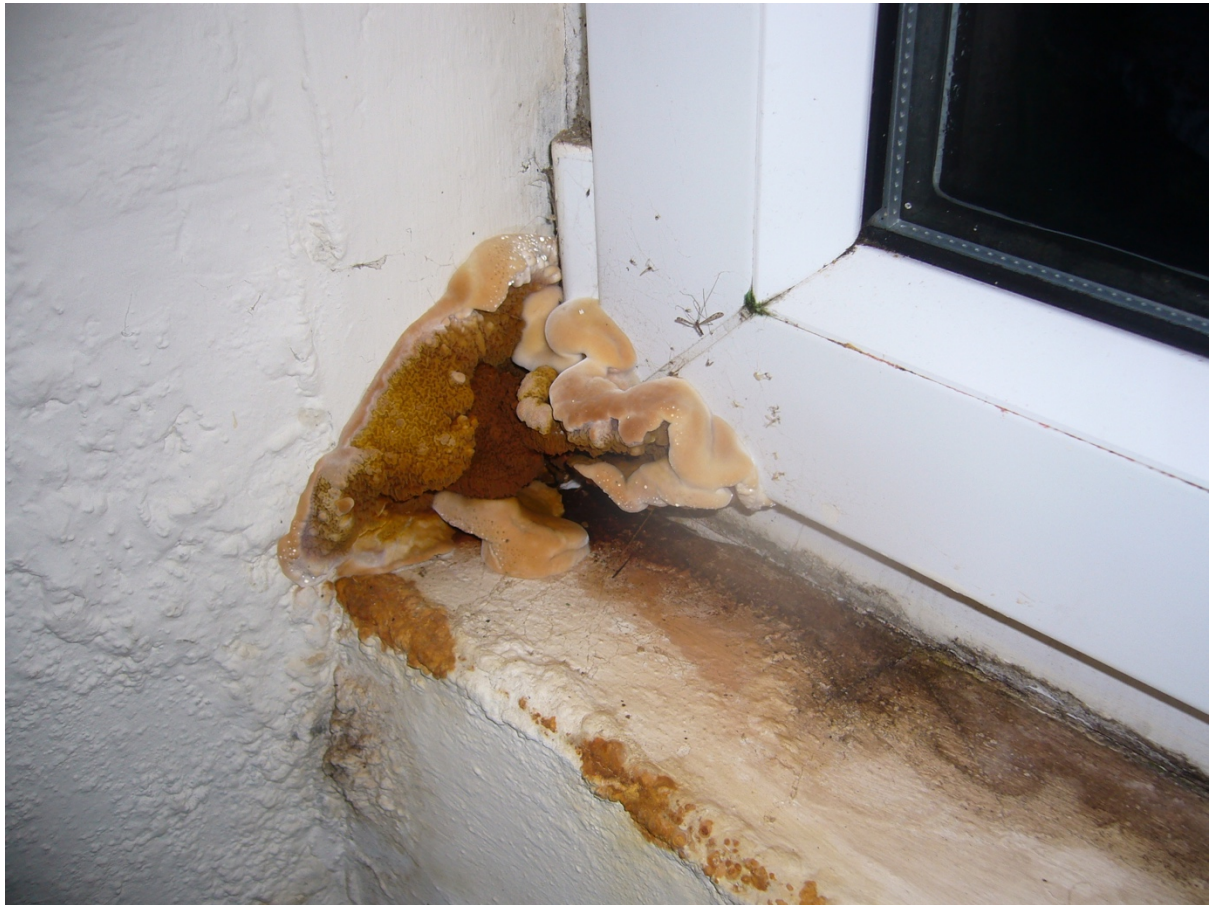
Over the weekend of 25th October 2008 at a curry meet at Tan yr Wyddfa, we discovered a large fruiting body of dry rot in the corner of the first floor landing window at the front (South) end of the hut.

Photo: Dry rot, landing window 25/10/08

Three dry rot treatment companies were approached for quotes. Specialists Peter Cox Ltd. were awarded the contract for dry rot treatment along with building contractor Peter Banham to do the building/structural work. Cox's inspection¹ revealed dry rot infestation and damage to skirting boards, floorboards joists and timber stud partitions on the first-floor landing and southeast bedroom. The infection had also spread downwards to the lounge window and front door lintels. Treatment would include replacement of damaged and infected wood and mass flooding of walls with fungicide. Peter Banham's work would include hacking off external rendering and internal plaster. This included both south bedrooms and part of the dining room wall, some of which would also be irrigated with fungicide by Cox's.

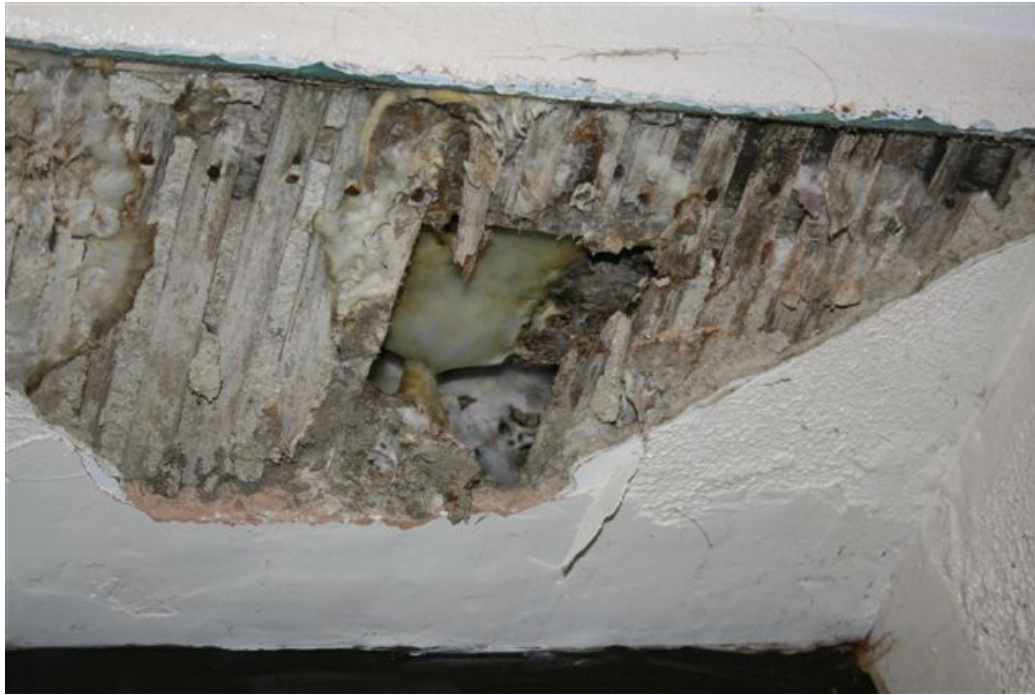
Dry rot hall ceiling November 2008

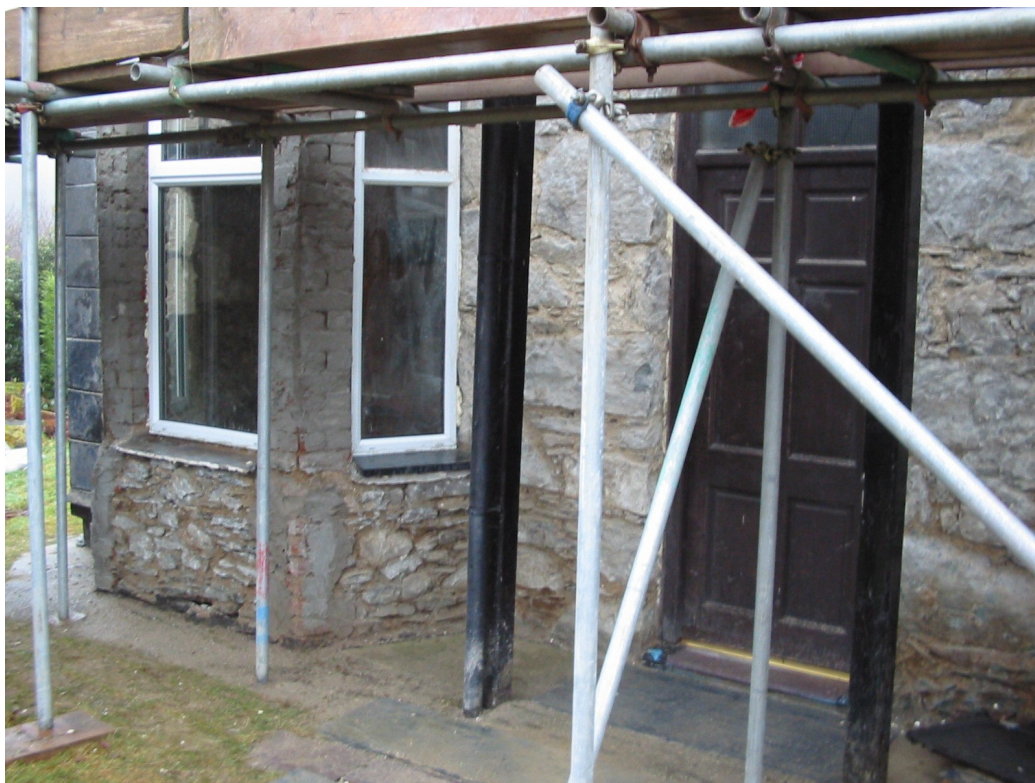
Dining room bay repairs March 2009

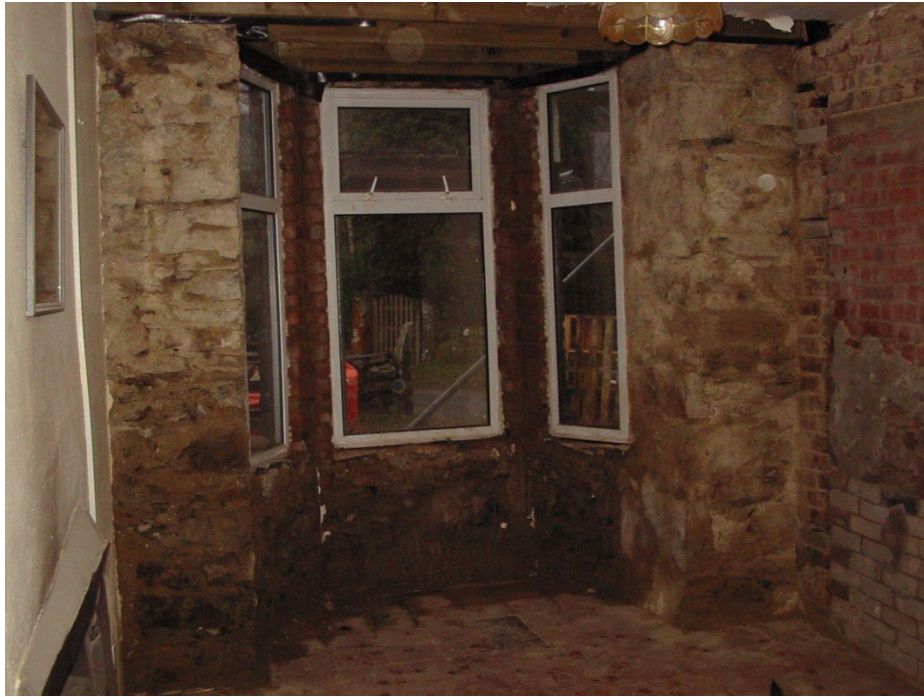
Lounge bay repairs March 2009

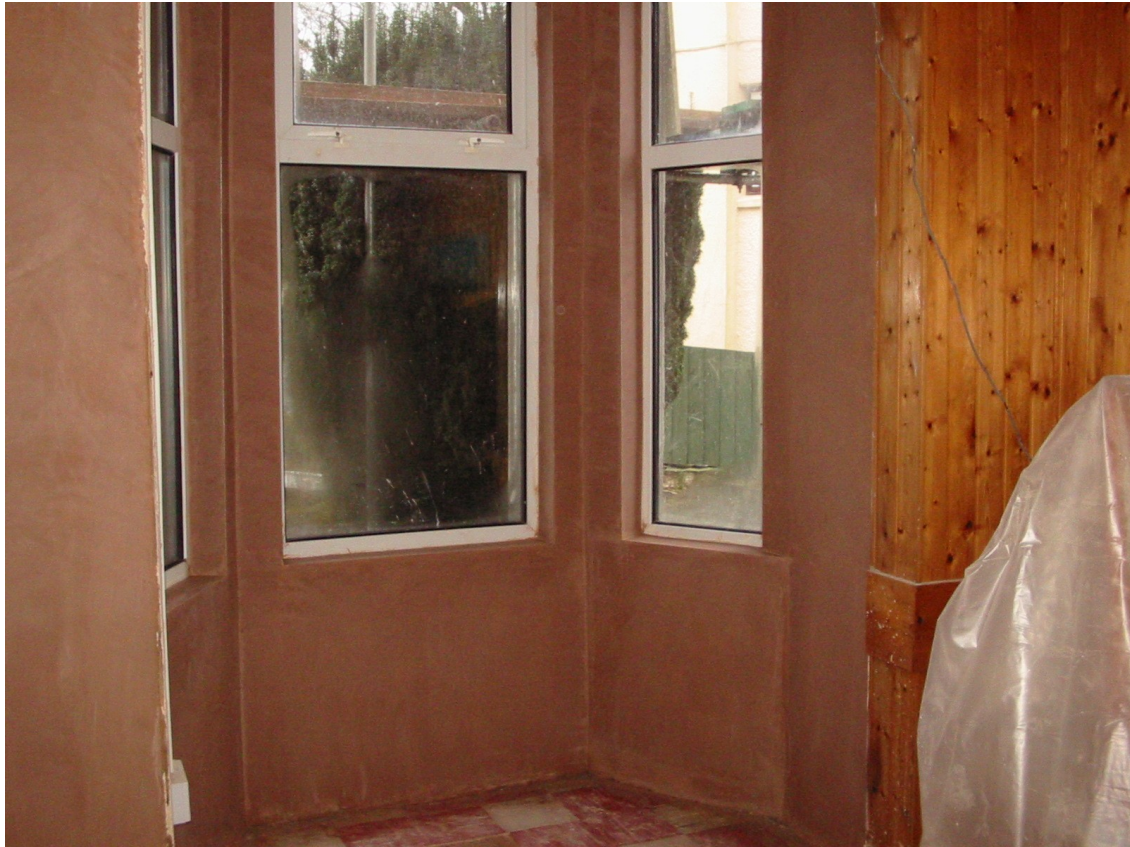
Dining room repair late March 2009

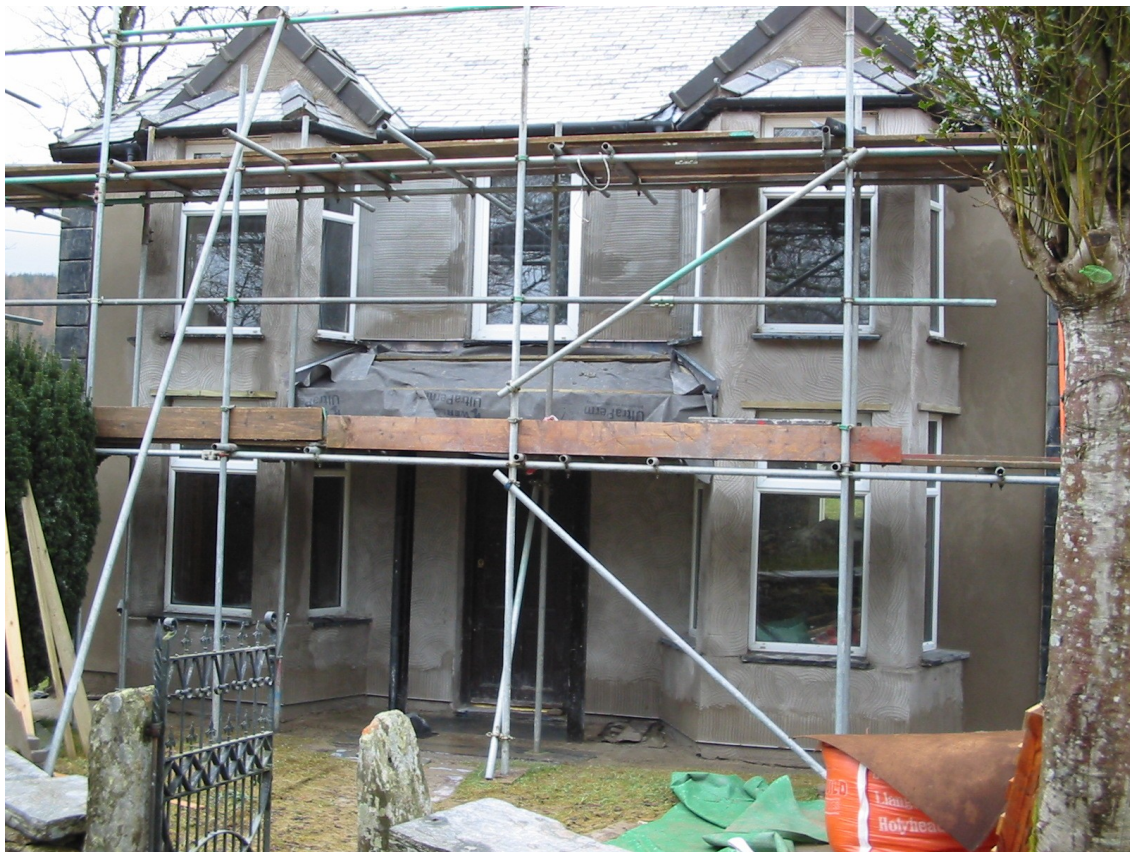
Exterior repairs late March 2009

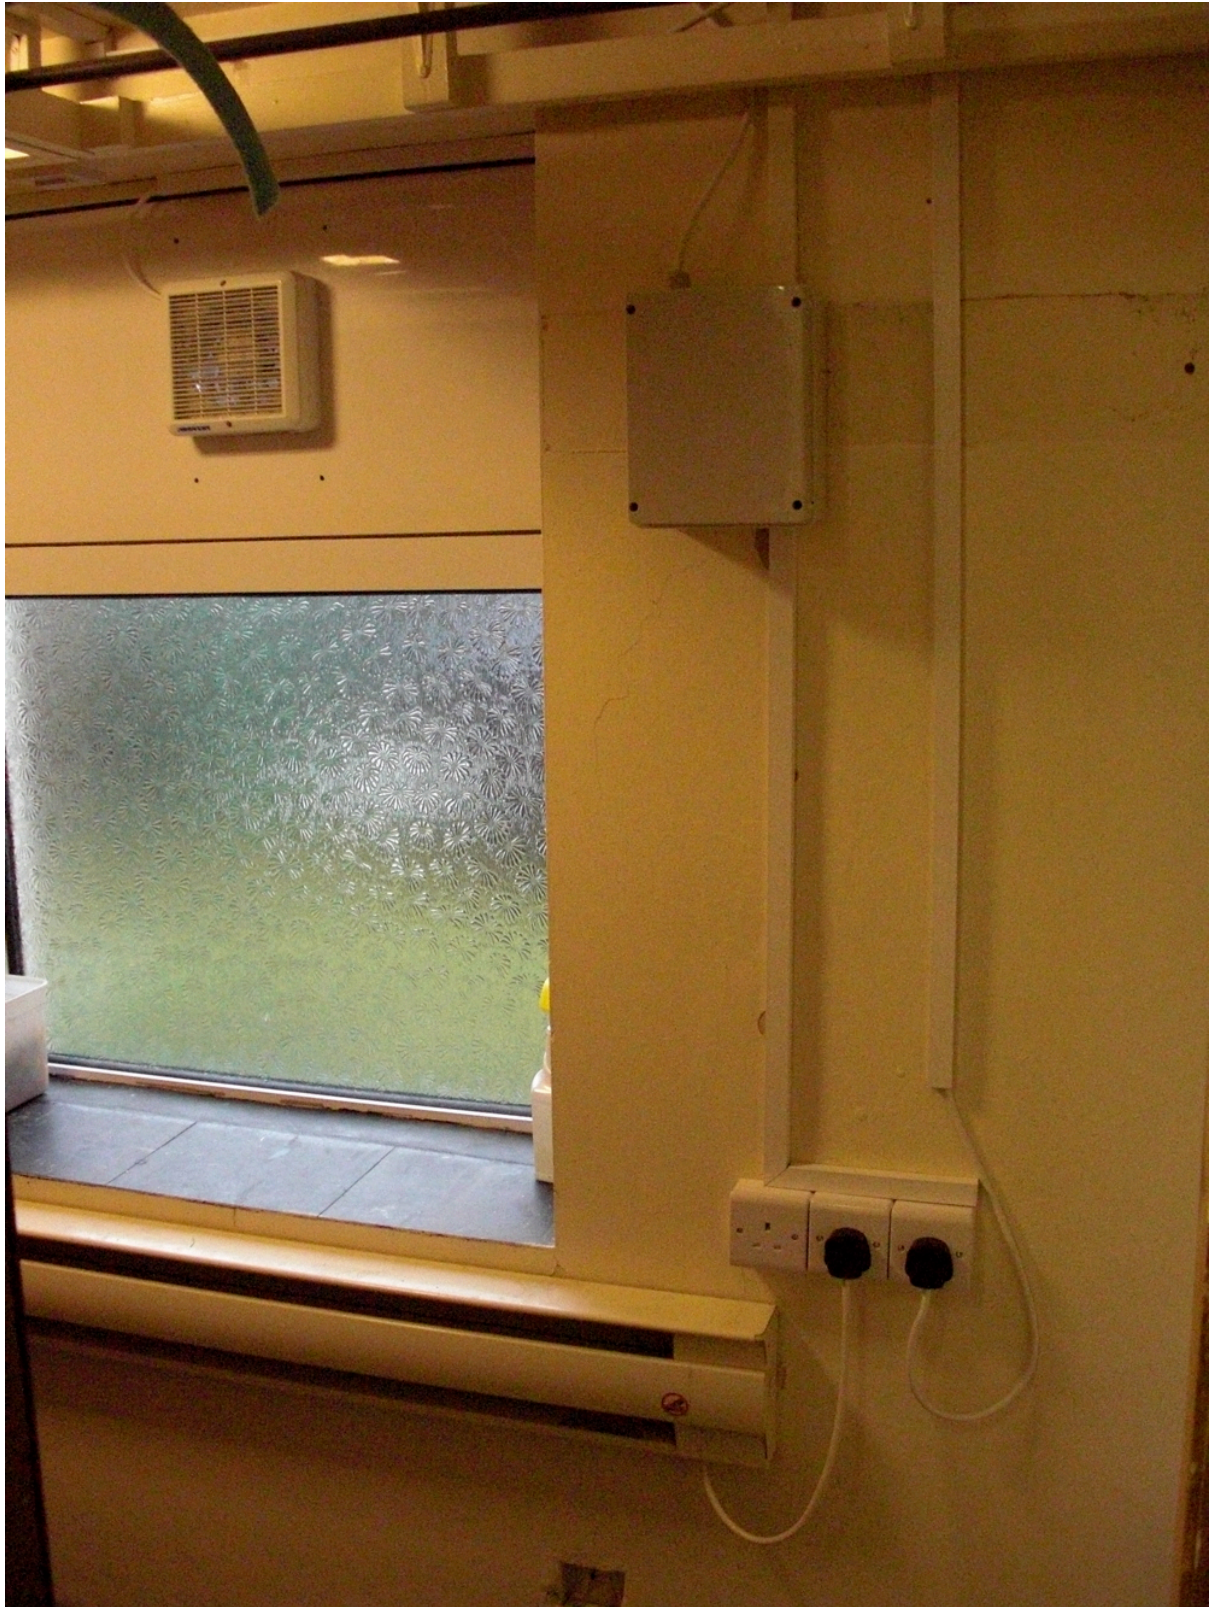
Photo: Original 2008 drying room extractor fan and heater

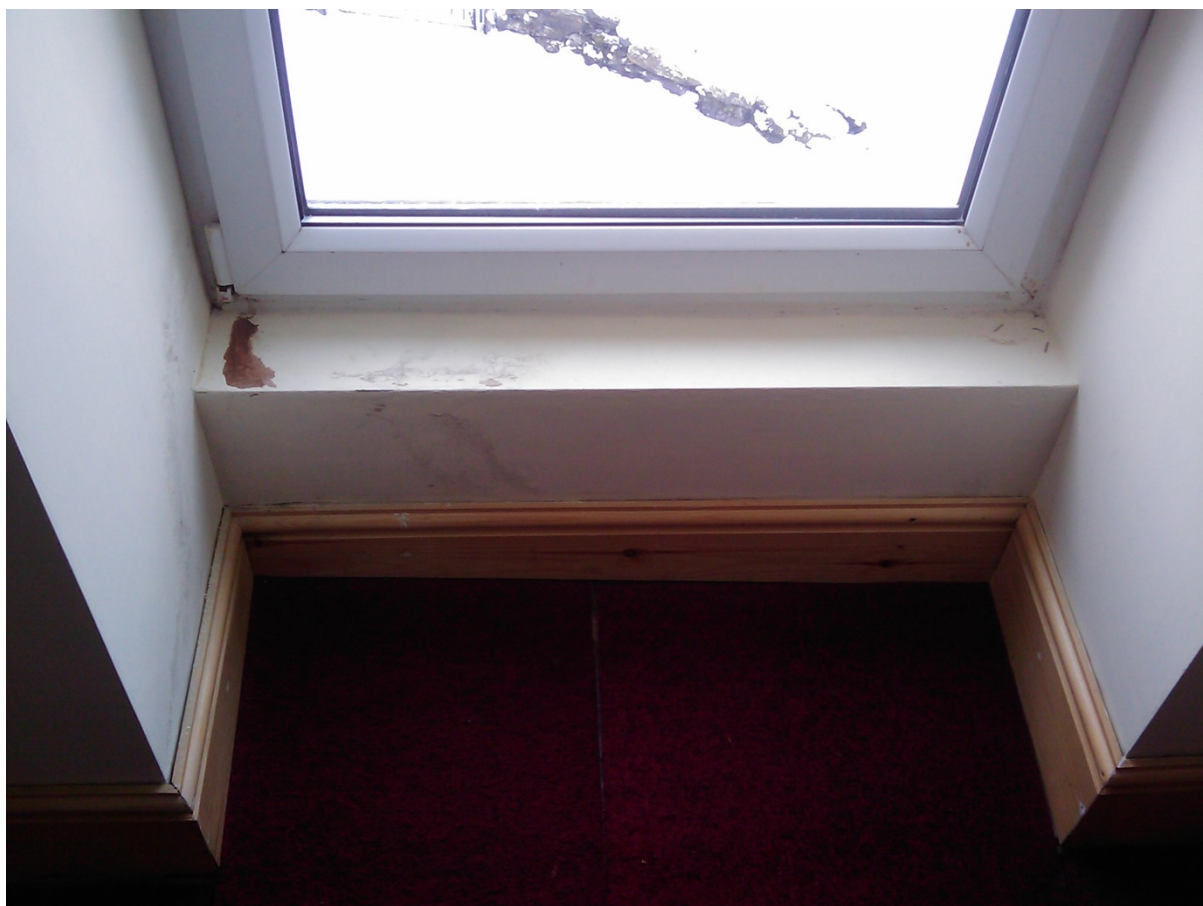
Landing window.

In late January 2010 John Green had confirmed the serious ingress of water in the walls, now in **both** front bays & the upstairs landing window. Reuben Dakin reported similar observations on 20th of February. The upstairs walls were found to be dry but with signs of previous water damage around the windows. Downstairs the lounge floor and the carpet were both still wet in the bay window. In the dining room, the bay was dry but there were signs that it had previously been damp.

Rising damp evidence 21/02/2010 (4 photos see below)

We discussed a new drainage system with Peter Banham and settled on having piped drains from the bottom of each downwards drainpipe and fed into the hut's sewer outlet pipe. We would embed this in a trench also containing a French drain (with solids trap) to draw away any groundwater which might accumulate under the front of the hut.

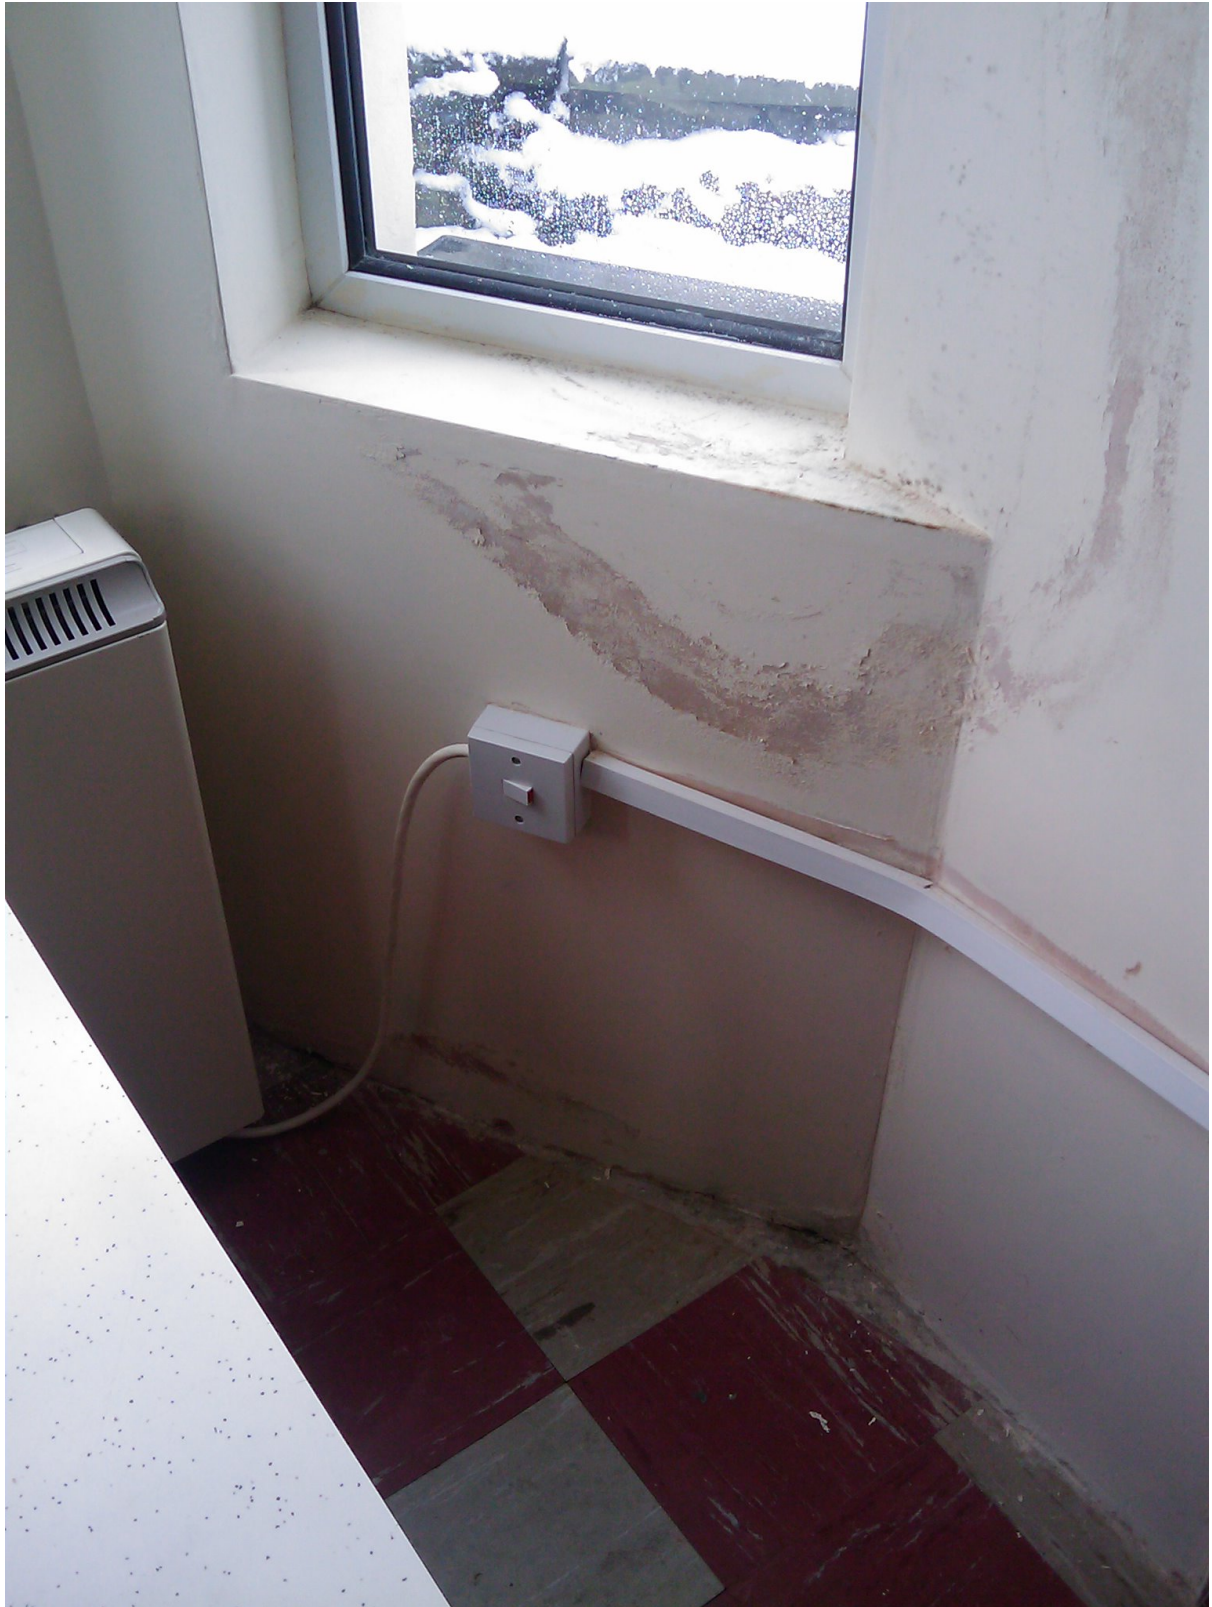
Dining room bay.

This evidence suggested that there was probably more than one source of water ingress, but rising damp was likely to be a major contributor to the wet floors in the bay windows.

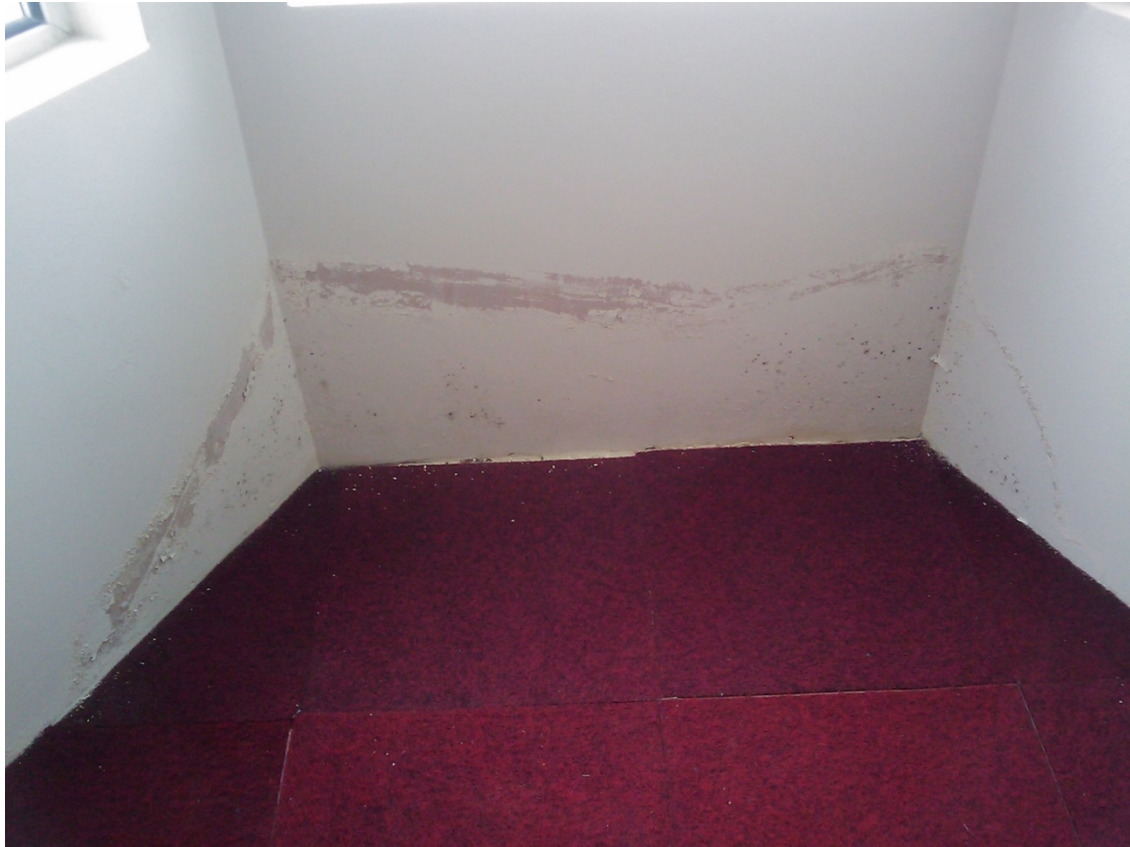
Lounge bay.

On the 5th March I visited site and found all areas dry except the floor in the bay of the lounge which was still damp.

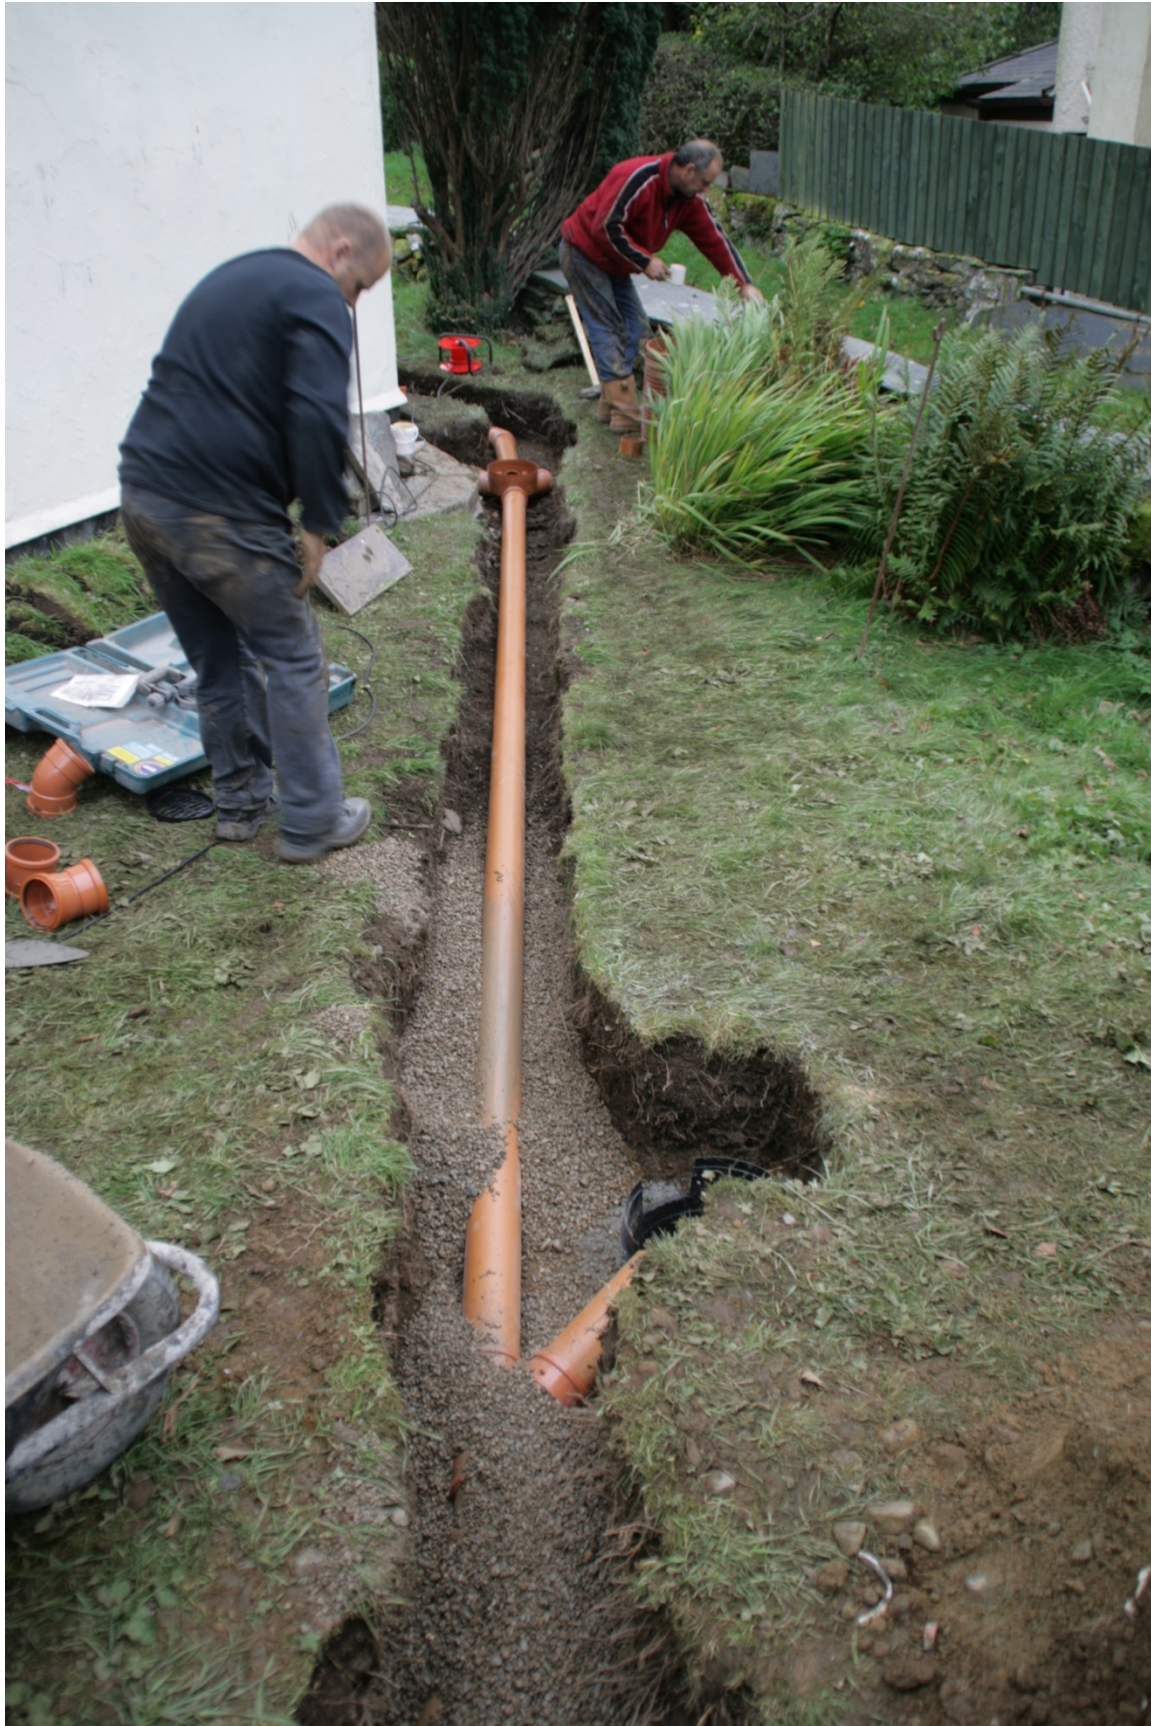
New drain, ground water solids trap, and access branch in SW corner of hut. September 2011.

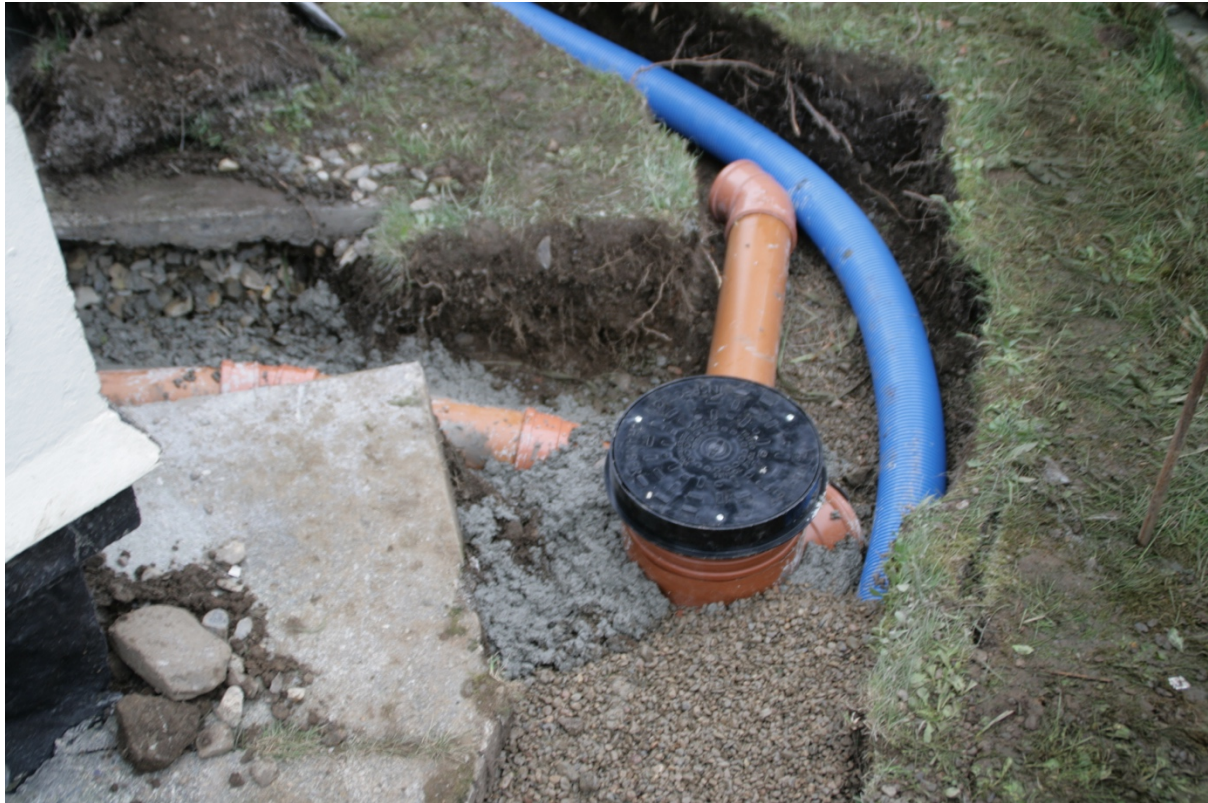
Access branch and ground water perforated pipe at SW corner. September 2011.

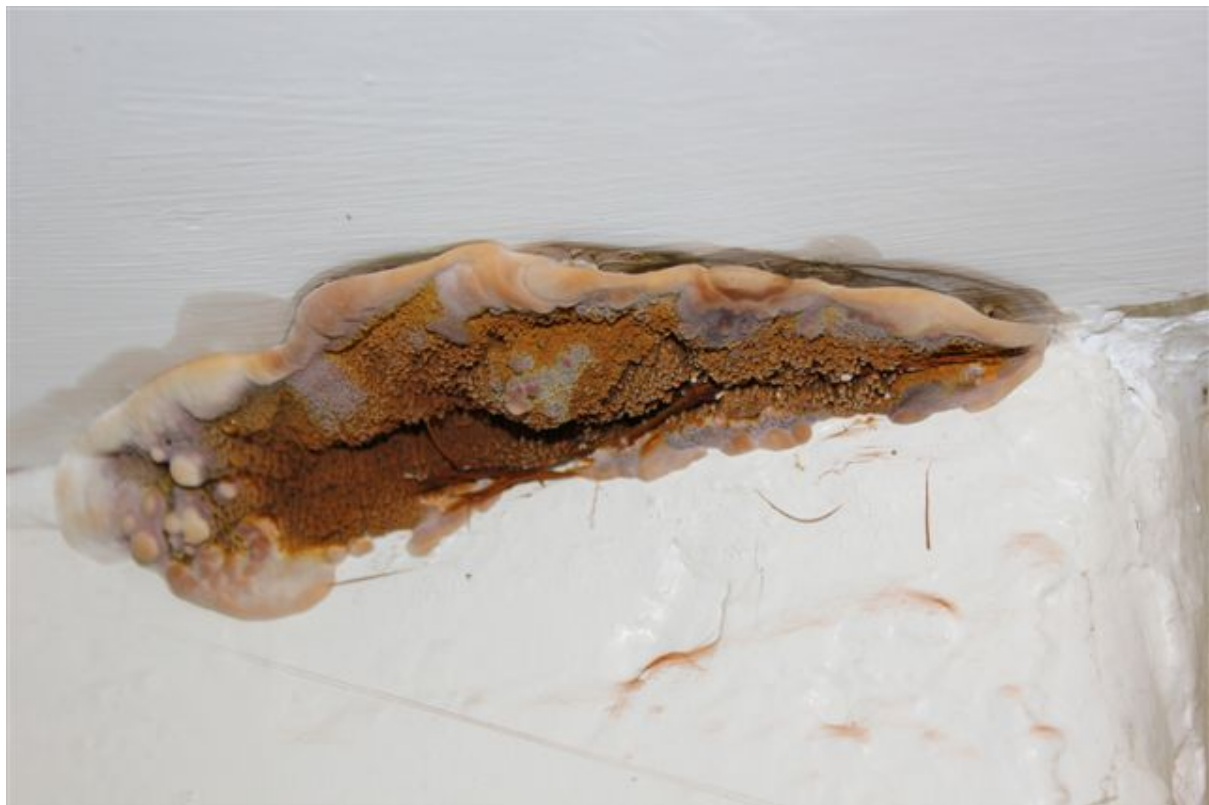
On the 4th of August 2012 Colin Hobday reported a new dry rot infestation at Tan yr Wyddfa, this time at the north end of the building. He and other HSC members had been conducting maintenance work over the previous few days. He identified & photographed a fruiting body in the top RH corner (looking out) of the kitchen window recess, and rotten wood in & under the

Dry rot over kitchen window.

It was clear that there was no lead flashing here, and probably never had been. There was only a rusting and disintegrated metal one, perhaps galvanised steel. We might have expected lead flashing embedded between the 'bricks' of the vertical main wall and fed under the slates of the lower roof. However, it was clear that since the wall was faced with irregular-sized and shaped stones it would not have been simple to embed the flashing into the wall. Clearly an alternative method of obtaining a robust seal would be needed for us.

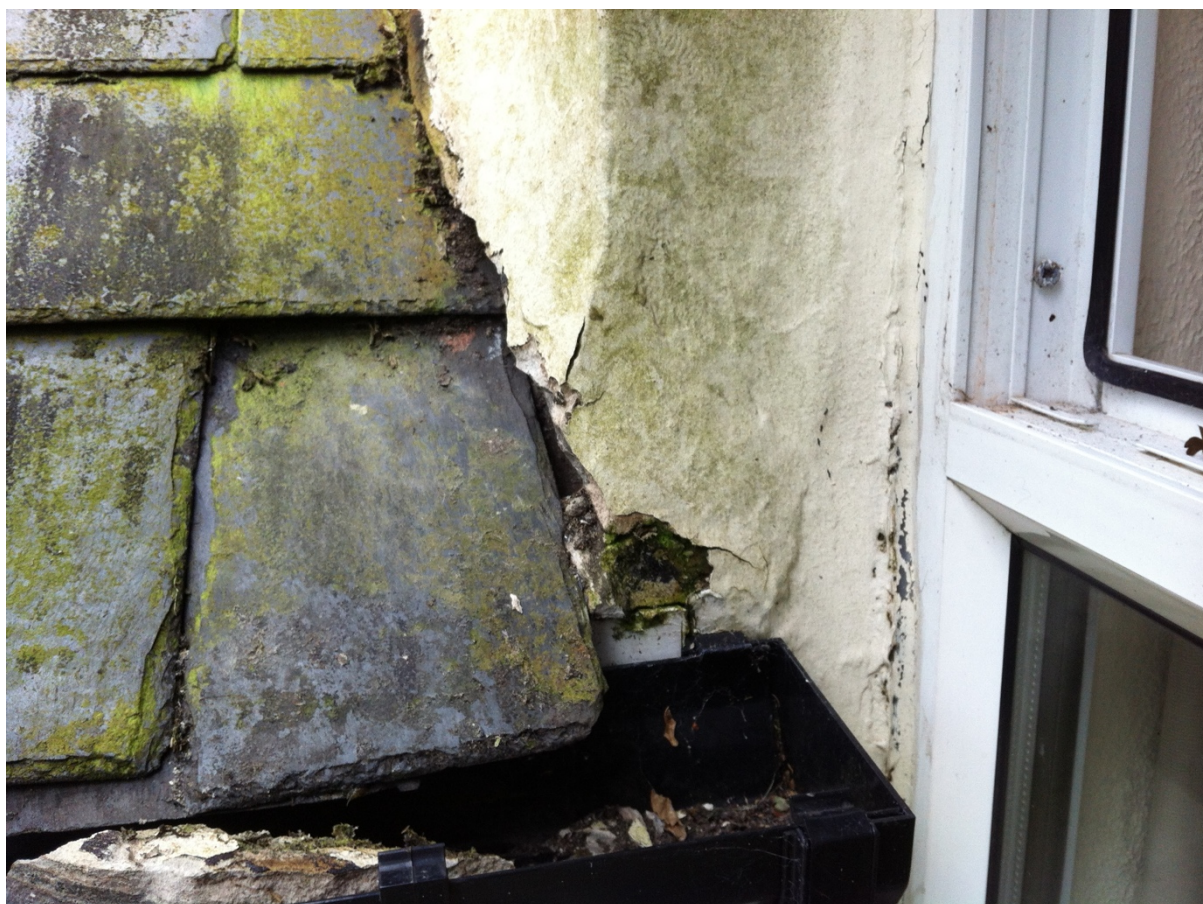
Extension roof, west (Y Garn) side showing poor seal.

Chuck informed us that the lower building had been extended northward in the 1960s and this new section had obviously been fitted with a new slate roof. Also, the main building roof had been replaced in 1994. This meant that the southern section of the lower roof, that which abutted the main building, was the only roof section of the whole hut that was original.

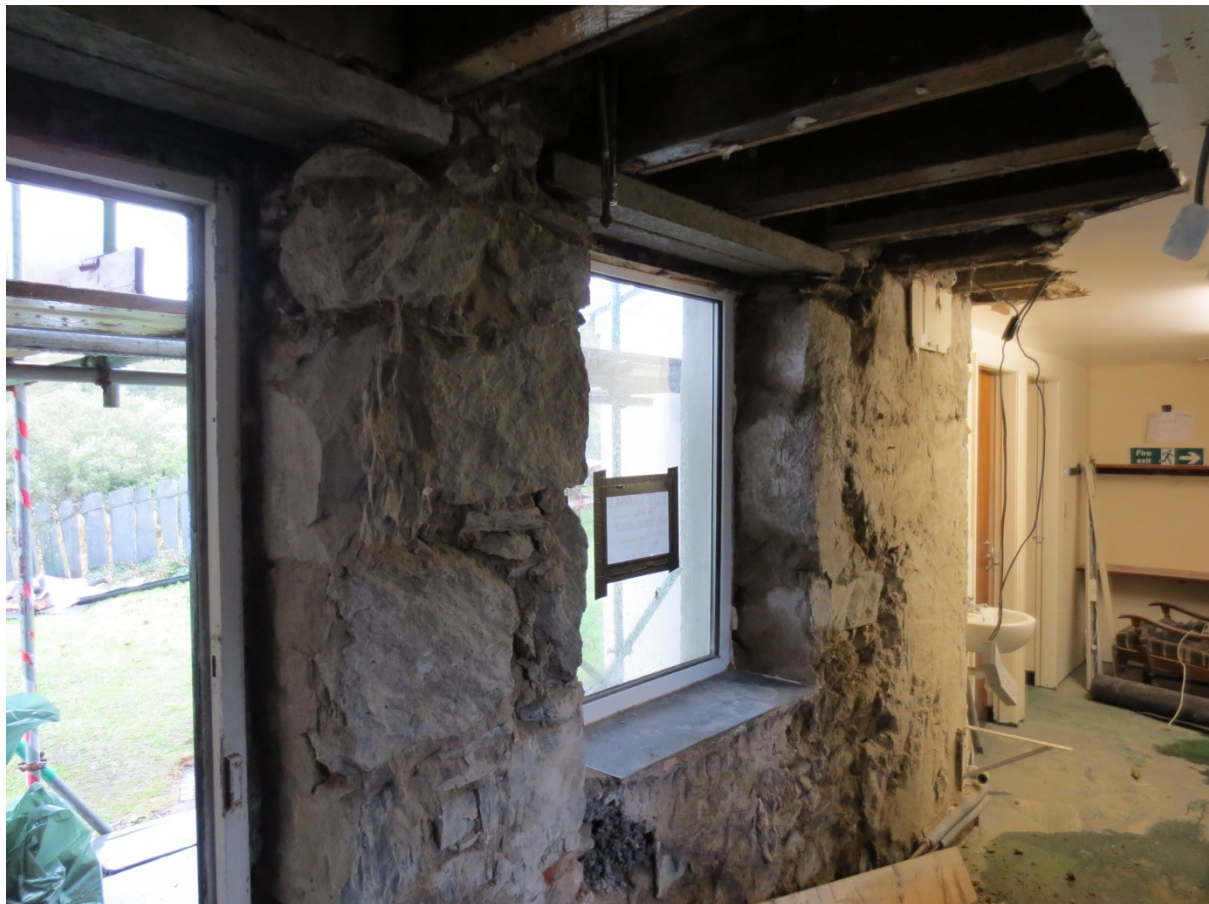
New Concrete lintels over back room door and window, walls stripped.

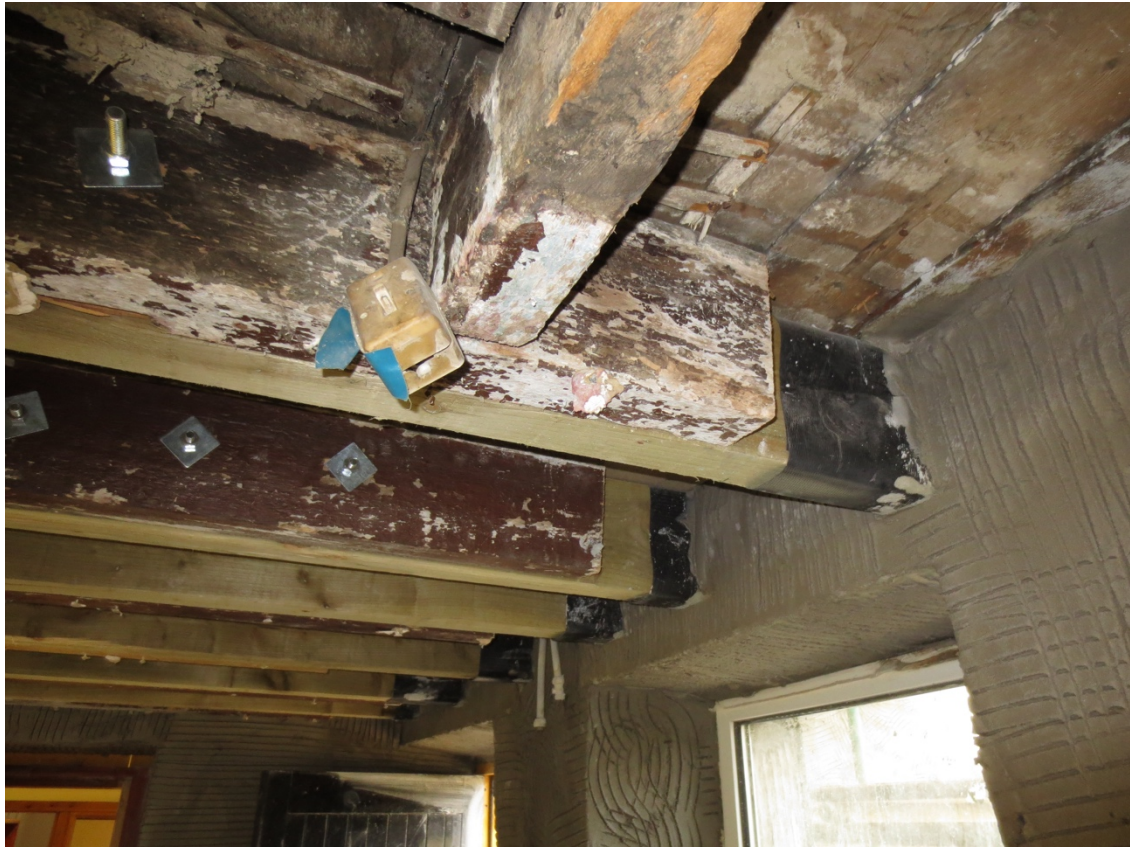
Replacement joist ends (protected) over back room door and window

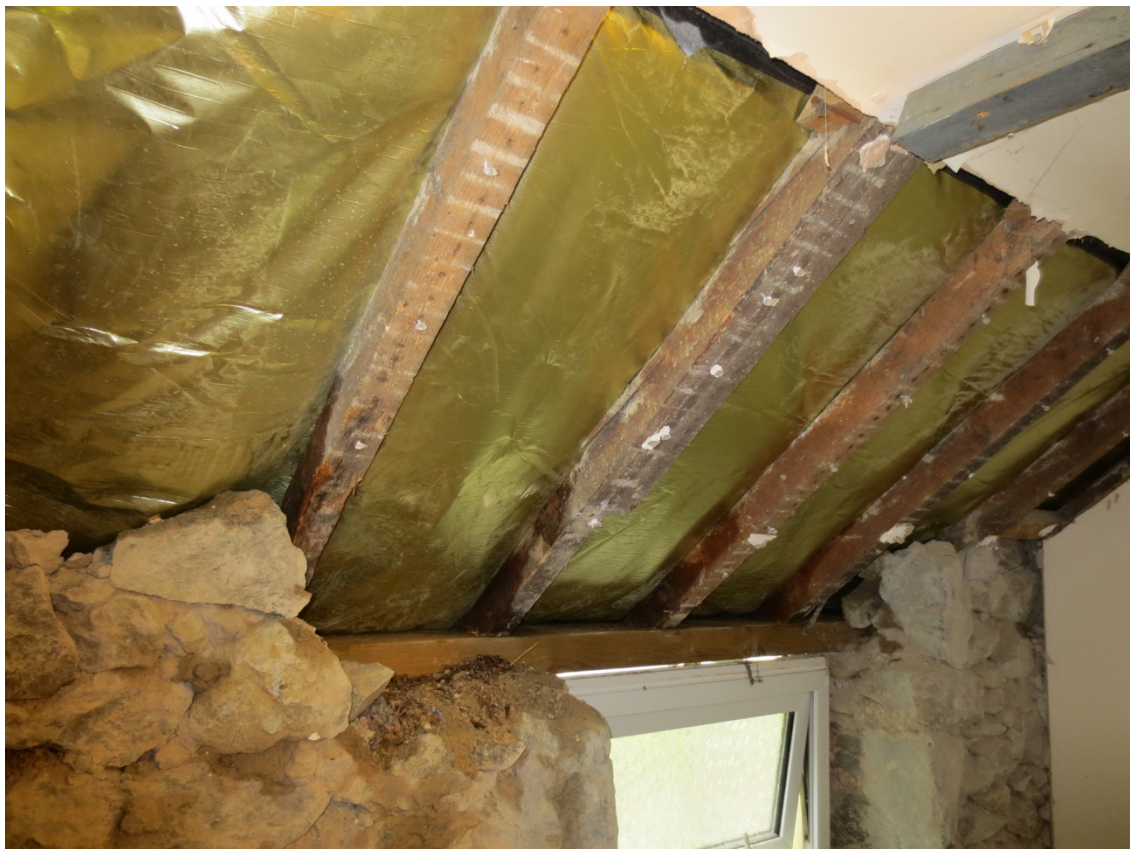
New wall plate and roof insulation above toilet.

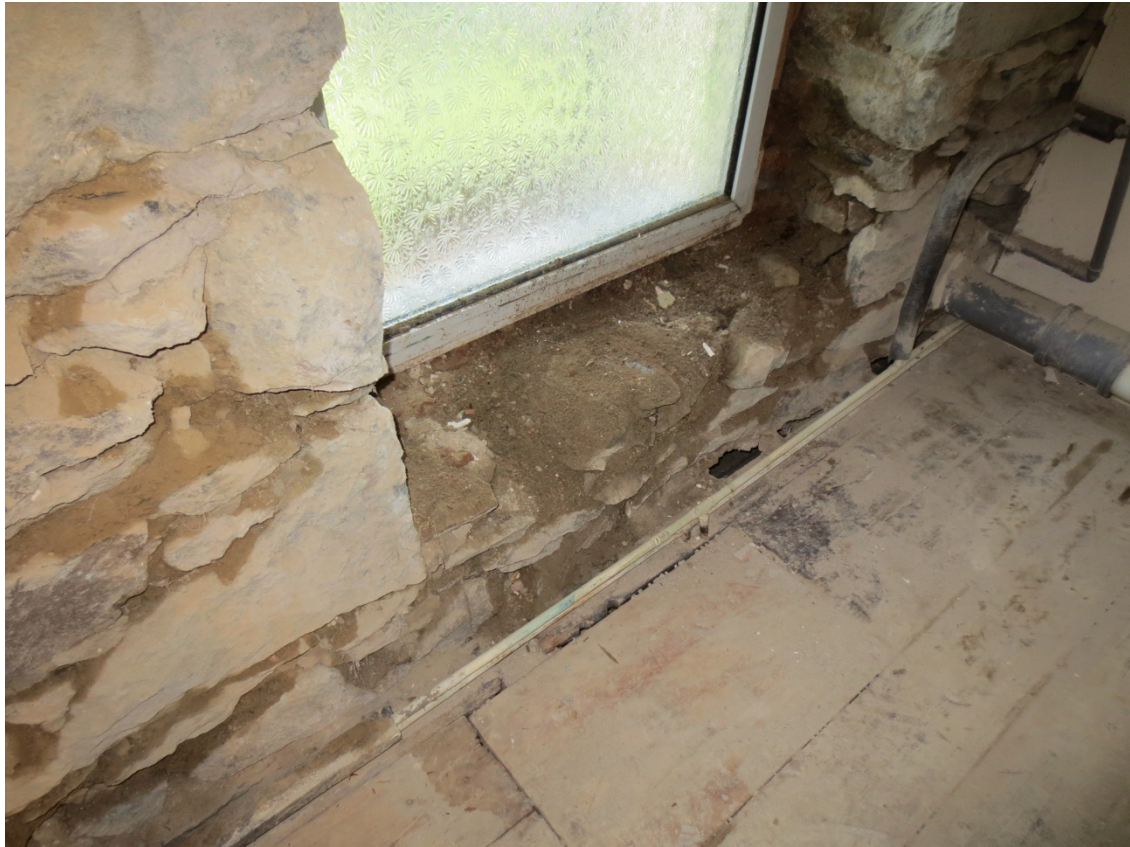
Toilet wall of soil filling.

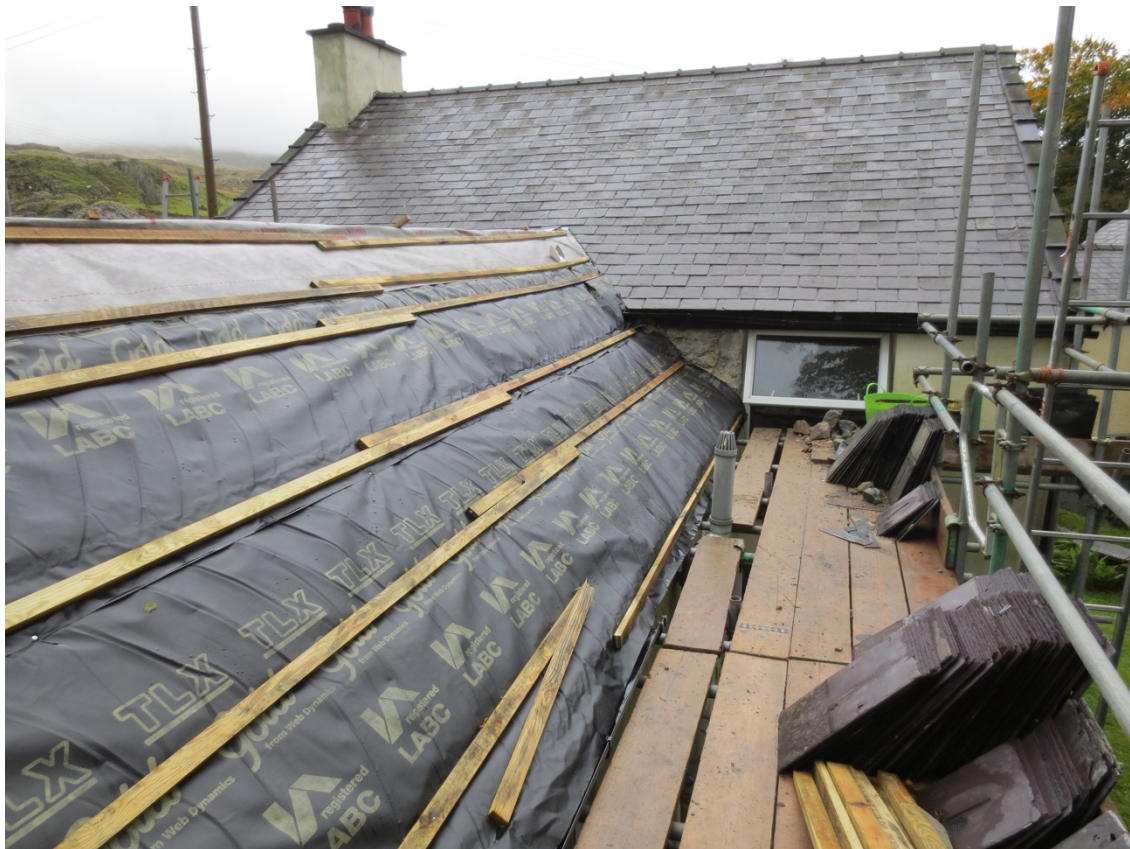
West side new roof with breathable felt and insulation.
