Tan yr Wyddfa Hut Sub-Committee & Hut Custodian 2008 to 2013 - Tony Howard

Dry Rot Treatment at South End of Building: October 2008 – April 2009

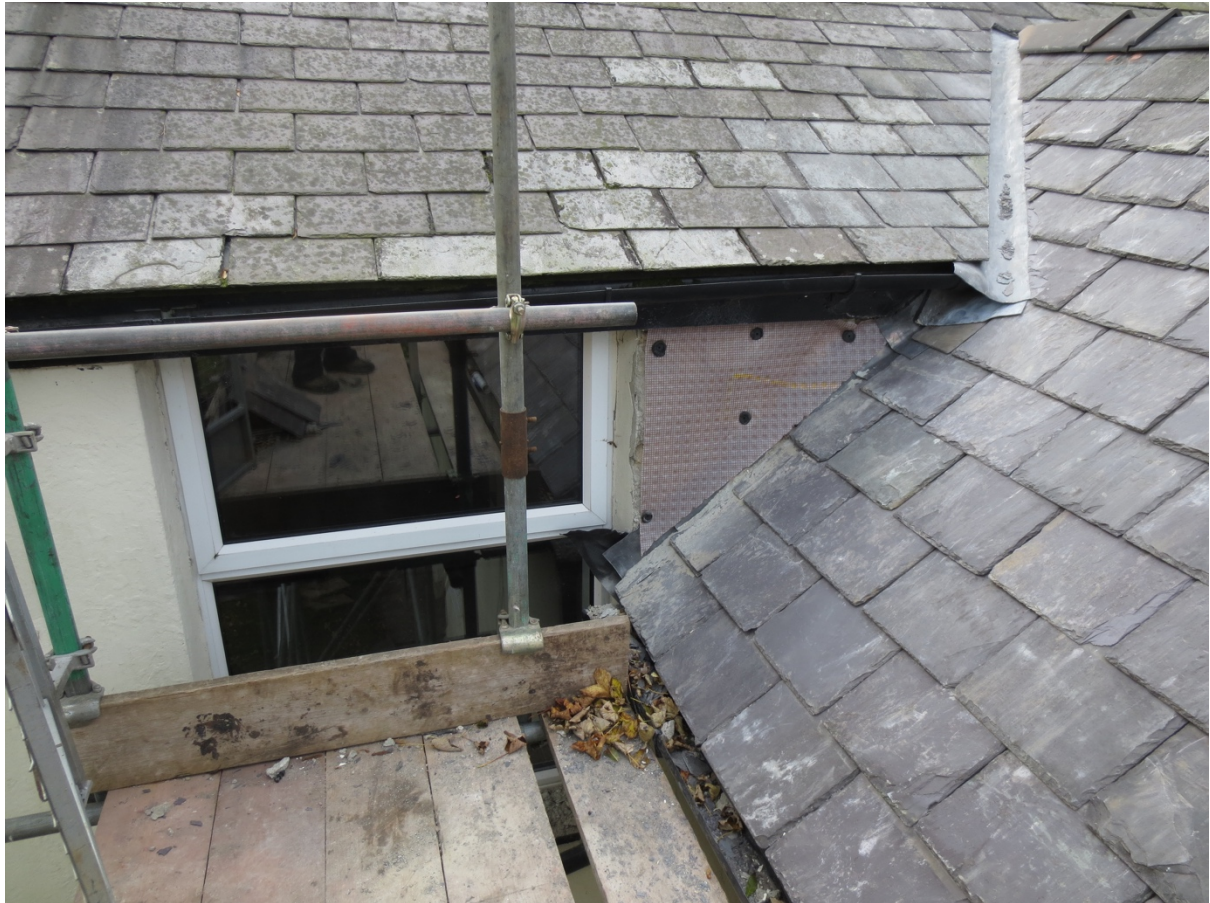
New lead soakers and protective cladding east side.
